Spark Gap Insulator Wall Survivability

William Wright, Jr.
US Army Electronics Technology & Devices Laboratory, (ERADCOM)
Fort Monmouth, NJ 07703

SUMMARY

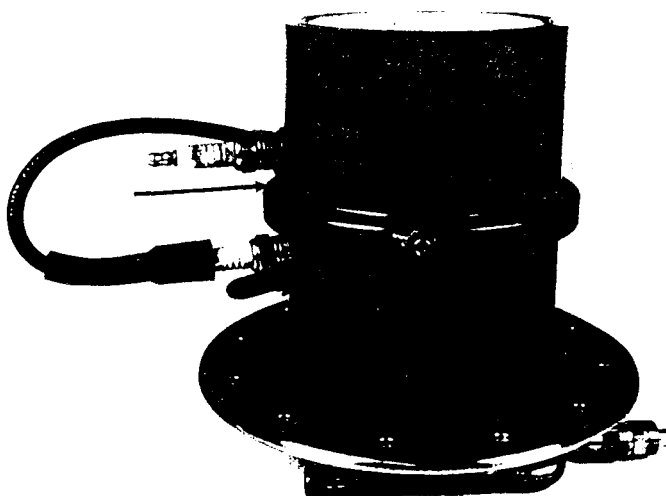
Figure 4 Deformed Acrylic Wall

The as-delivered spark gap used cast acrylic walls, 4.0 in. ID and 0.375 in. thick, and an uncooled center electrode. The progression of damage with increasing repetition rate and average power was darkening of the walls, shallow axial crazing in the line-of-sight region, surface melting of the crazed region, and finally softening and gross deformation of the wall edge in contact with the center electrode, as shown in Figure 4, whose temperature reached 133°C, well above the softening temperature for acrylic. At moderate and high average power there was a strong acrylic smell in the exhausted gas, probably from the dissociation of polymers into monomers on the inner wall surface. There was no evidence of electrical tracking over the surface or damage from the acoustic shocking. The wall discoloration was a soft, sooty brown deposit, presumably copper evaporated during the pulse and oxidized before reaching the walls. Any UV solarization of the acrylic was in a very shallow layer at the surface, as would be expected from the high attenuation of UV in acrylic. The walls were easily cleaned with mild abrasive cleanser and water. The arc associated with a prefire fault, during which the capacitor bank dumped and the power supply drove its short-circuit current through the spark gap until the main breaker cleared, was lower current but of much longer duration. This longer time allowed significant arc motion, often leaving a meandering track on the electrode surface up to 0.5 in. long, moving under the influence of magnetic and gas dynamic forces, predominantly away from the current feed. Where the errant arc attached itself to the electrode-wall interface, the result was a heavy deposit of metallic copper, strongly bonded to the wall surface.

These walls were satisfactory at very low average power, such that the thermal limitations were not reached. A liquid cooling coil was added to the center electrode to eliminate the heat loading conducted from it to the acrylic, and a new set of acrylic walls ran 10⁵ shots without failure, although there was serious surface damage, a reduction of thickness by 0.025 in., and

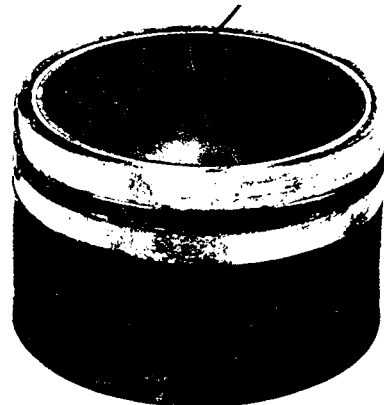
Figure 7 Transite-Acrylic Composite Wall

To capitalize on the good electrical properties of acrylic and the thermal properties of Transite, a composite wall was made from a 1.0 in. ring of Transite joined to an acrylic wall with a cylindrical step-joint. The Transite rings needed external metal reinforcing bands to maintain physical integrity because the presence of the holes for the spark plugs reduced the cross section of the ring by over 50 percent. Figure 7 shows these walls after 144,000 pulses at 8 kJ and 0.4 C with a prefire rate of approximately 5x10⁻⁴, equivalent to the acrylic walls alone. The major damage evident is the crack in the Transite, which occurred before the metal bands were applied, and the wearing away of the Transite around the crack from ablation and the scrubbing action of the gas flow. These walls were still servicable when shut down.

The Transite rings are inherently weak, and the machining necessary to join the materials makes the composite no longer inexpensive, but this wall gave satisfactory results at 0.24 Mw average power for 15 s burst length for hour-long runs.

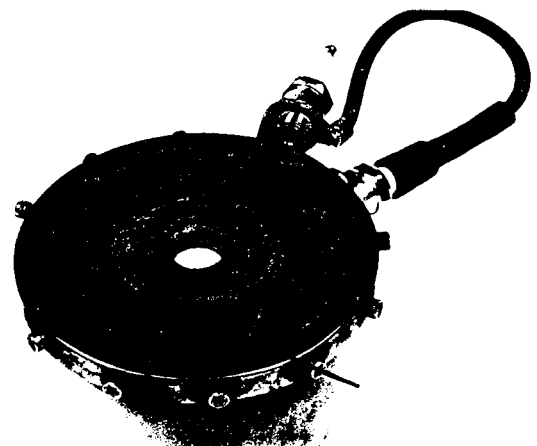
Figure 8 Fused Silica Wall Showing Kickout Arc Spot

mechanical strength, and UV transmission which allowed placing the pre-ionizing UV source, the spark plugs in this case, outside the gap envelope. With 0.187 in. thick fused silica walls the gap ran for much of one day at 0.32 Mw for many minutes at a stretch, with a total pulse count of 43,000 pulses and a prefire rate of 4x10⁻⁴. Enough heat was deposited in the center electrode to slightly blue it, but there was no apparent damage to the walls. The next day, however, after a few seconds at low repetition rate and no kickouts, the upper wall exploded. Autopsy showed no sign of the 45° angular cracking characteristic of fused silica which has been thermally abused, but that some of the knockout arc spots had migrated to the wall-center electrode interface. A little known characteristic of fused silica is its disparity between short-term and long-term mechanical strength¹, due to the slow propagation of surface microcracking through its volume. The postulated failure mode is that one of the knockout arcs near the wall, see Figure 8, created surface cracking which, over a few hours, propagated through the wall, weakening it sufficiently that the pressure pulses from normal operation the following day broke it. The presence of grinding marks from the fabrication of the walls may have exacerbated the surface problem.
